The Cathedral Stone NEWSLETTER

April 2008, Volume 4, Issue 1

Upshur County Courthouse Restoration

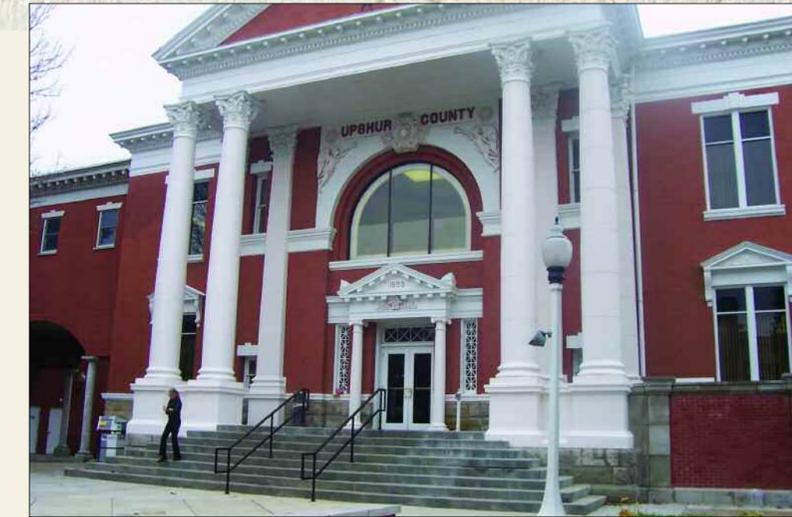
Upshur County Courthouse after restoration.

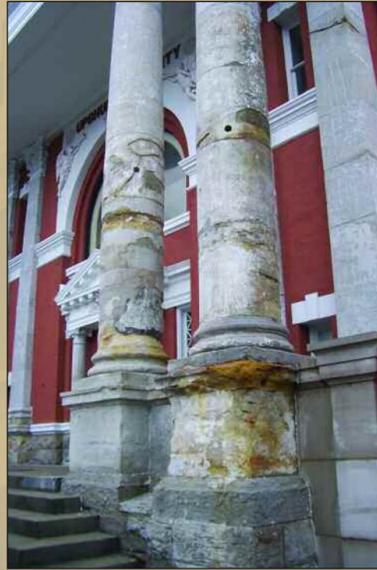
waterinfiltrated the system and could not get out. The water was trapped in the sandstone through freeze-thaw cycles and hot days, which essentially caused the deterioration of the stone below. The deteriorated stone pulled away, creating larger cracks and exacerbating the problem until sections of the parging began to fall from the columns. Unfortunately, the bond strength of the parging was greater than the material strength of the sandstone, and in many areas the parging ripped good stone away as it went.

Coatings were stripped revealing severely deteriorated stone.

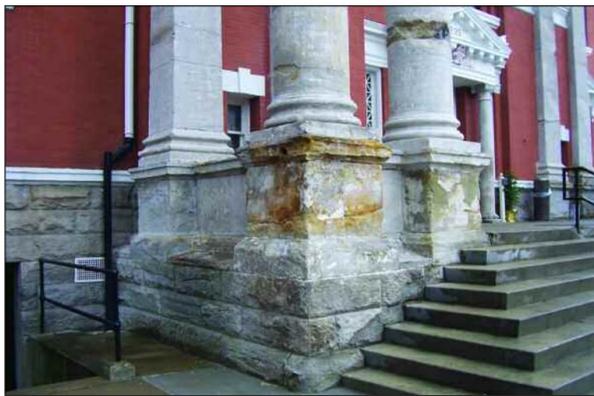
Repairs finished and coated with Silin Silith.

After all the mortar joints were repointed, the smooth-tooled areas of stone were coated with Silin Silith. This mineal coating has a very high rate of vapor permeability (70 perms). At the rock-faced stone, color-matched mortar and dutchman were used to match repairs to the existing substrate.

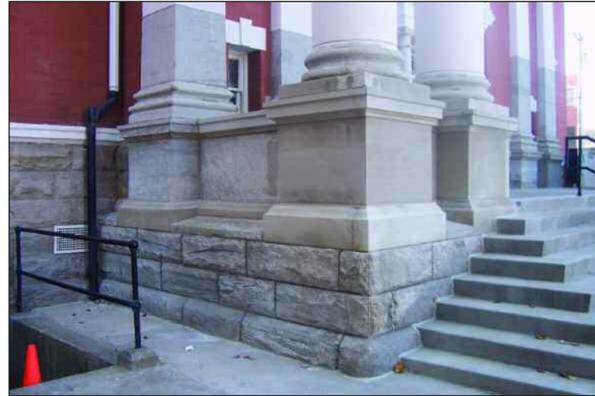
Repaired stone with Jahn M70 Repair Mortar before coating.

Some cracks completely transected the column shafts and were stitched together with stainless steel pins, anchored with Jahn M80 Setting Mortar. Ports were created to fill the crack with injection grouts and adhesive as appropriate. Surface cracks were cut out from the stonework and filled with Jahn M70 stone repair mortar, engineered to match the properties of the existing stone. The large non-shrink grout repairs at the column shafts required steel bracing to be installed before removal. Keystone Waterproofing contractors also used Jahn Repair Mortars to recreate the original profiling of the plinth area railings, column bases, pilaster bases and the scrollwork for an ionic column.

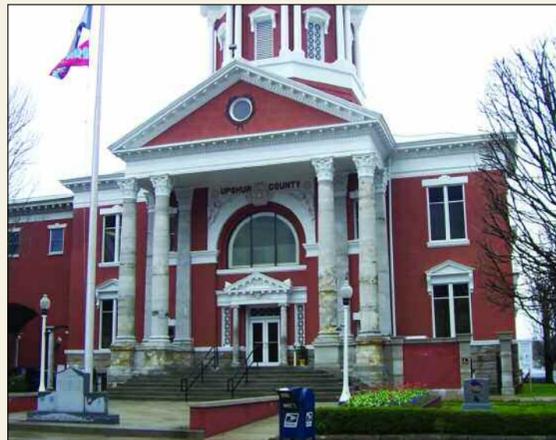
In 2006, the Upshur County Commission wanted to repaint the stonework at the portico on the courthouse. Chapman Technical Group, architects for the project, discovered in a previous effort to protect the stonework, the portico area columns, railings and plinths were coated with a cementitious parging, and painted with a waterproofing used for pool liners. However,

Upshur County Courthouse prior to portico restoration.
